In-Situ Monitoring and Testing of IBRC Bridges in Wisconsin

In-Situ Monitoring and Testing of IBRC Bridges in Wisconsin (WHRP 10-09). Milwaukee, Wisconsin, Marquette University, Department of Civil, Construction, and Environmental Engineering (2010).

WHRP 10-09

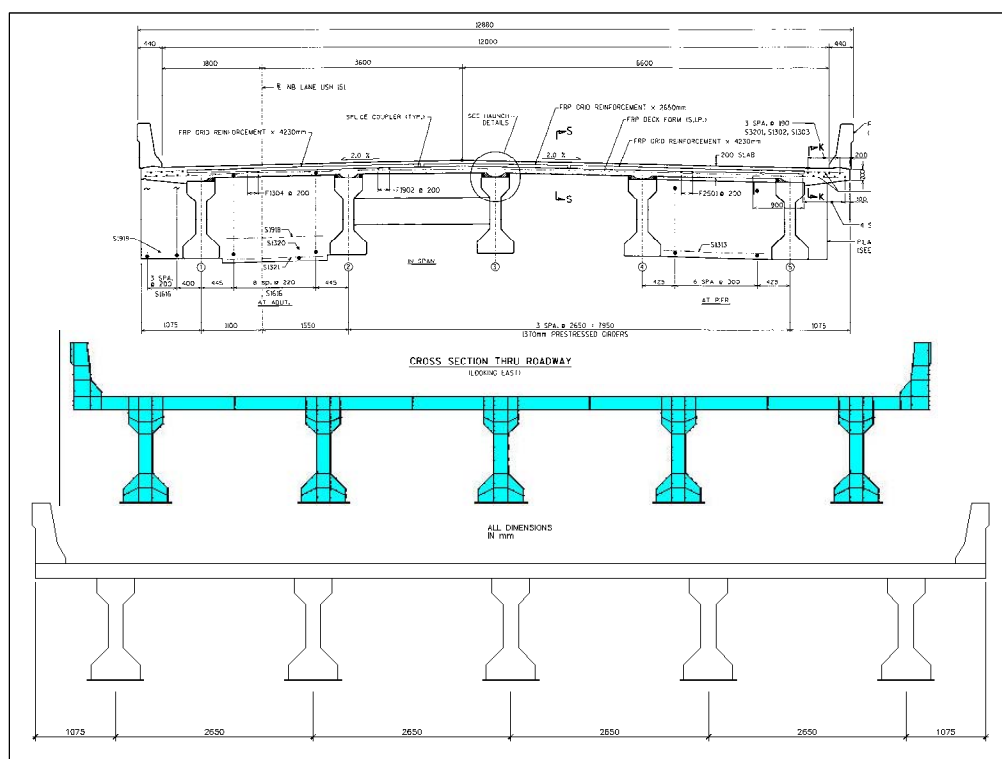
Figure 5.4 Bridge B-20-134 Cross Section (Komp 2009).

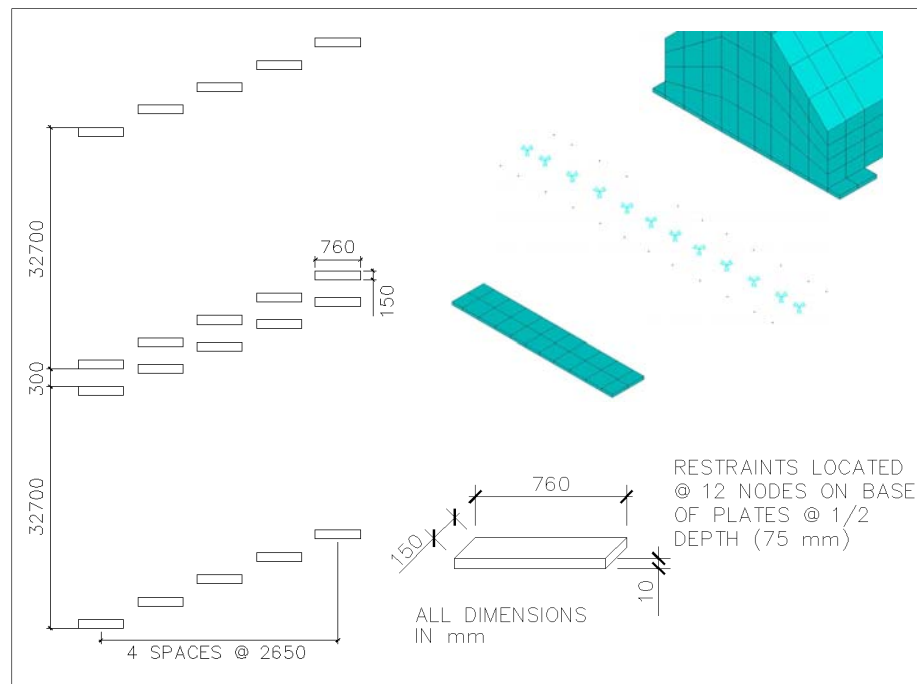
Figure 5.5 Steel Base Plate Modeling (Komp 2009).

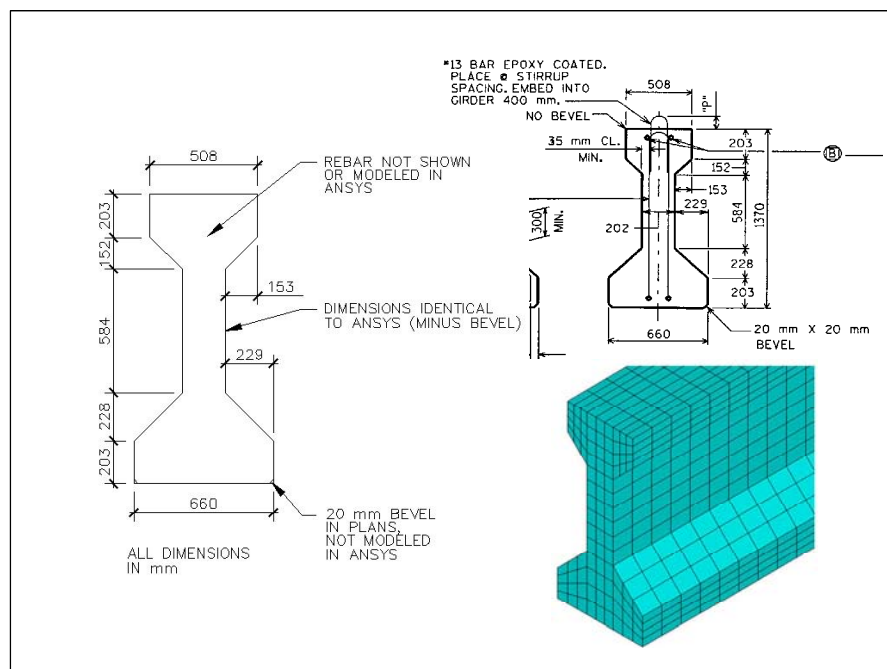
Figure 5.6 Modeling of Standard WisDOT 54'' Deep Precast Girder (Komp 2009).

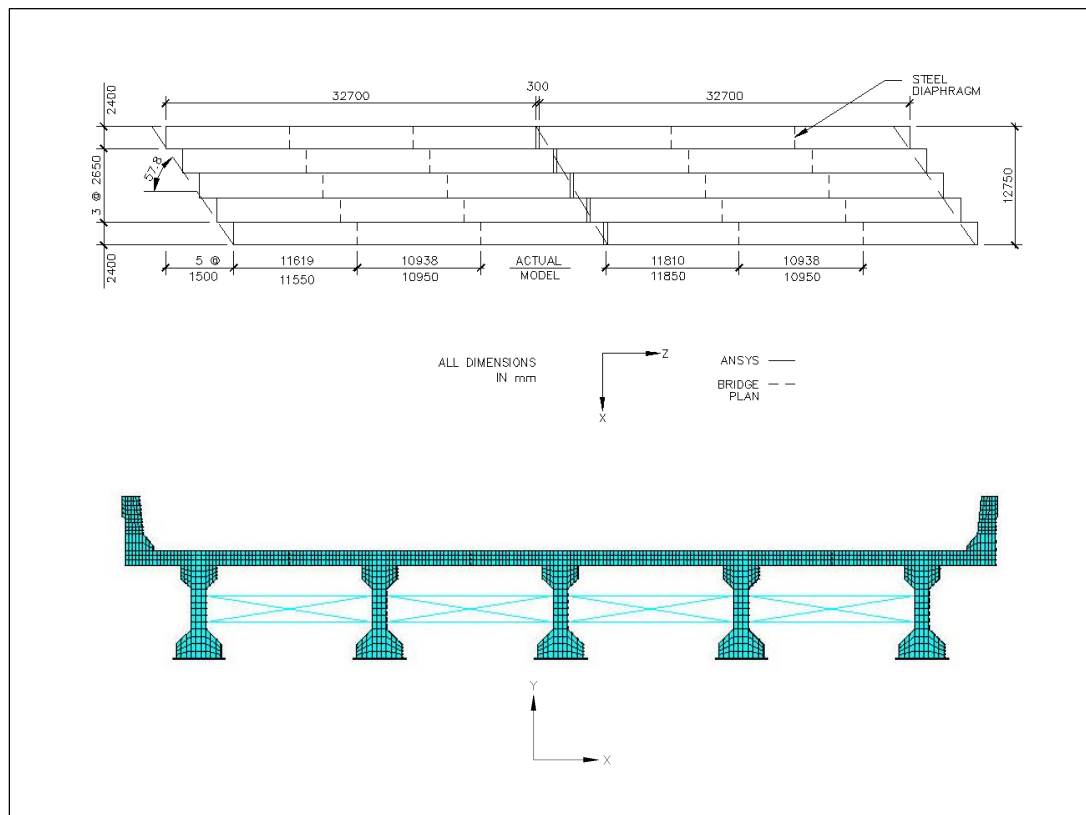
Figure 5.10 Steel Diaphragm Simulation and Locations (Komp 2009).

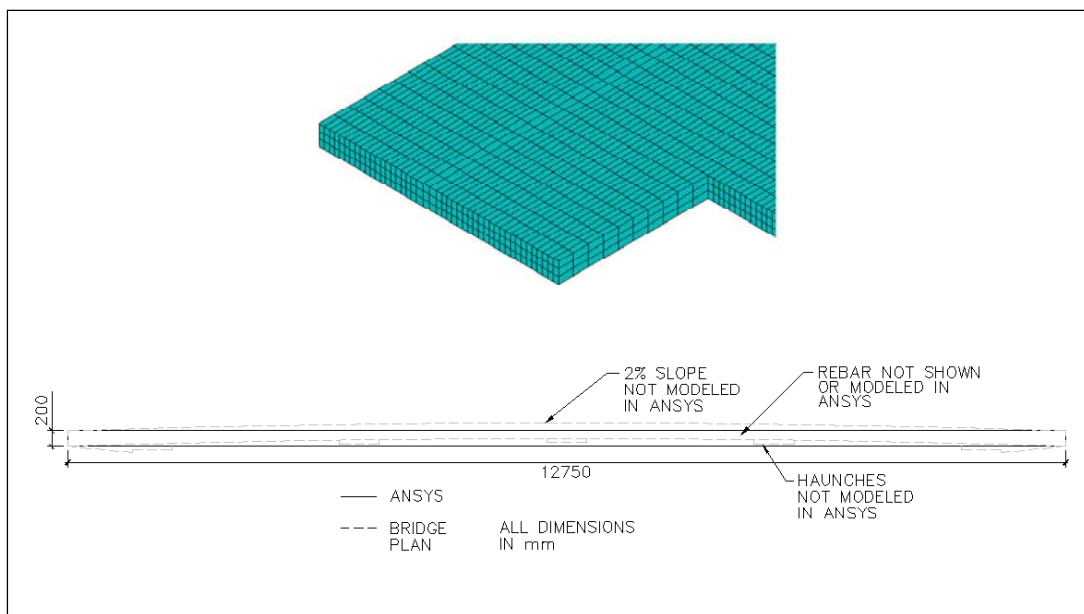
Figure 5.11 Concrete Deck Modeling (Komp 2009).

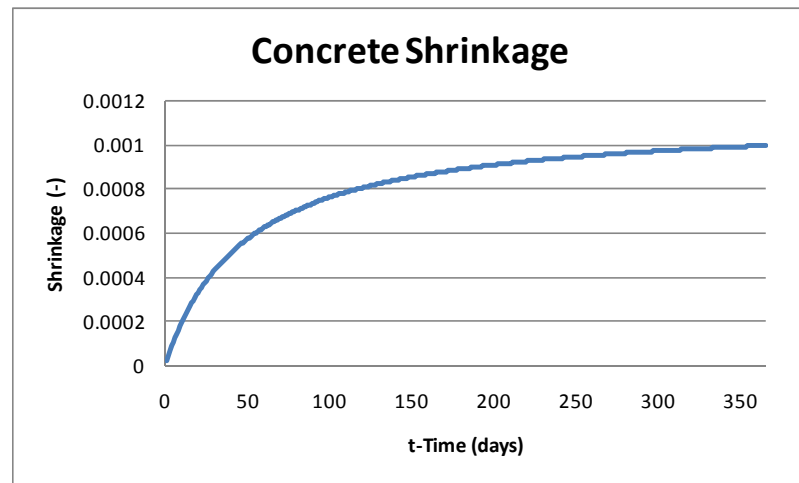
Figure 5.13 Concrete Shrinkage with Respect to Time (Komp 2009).

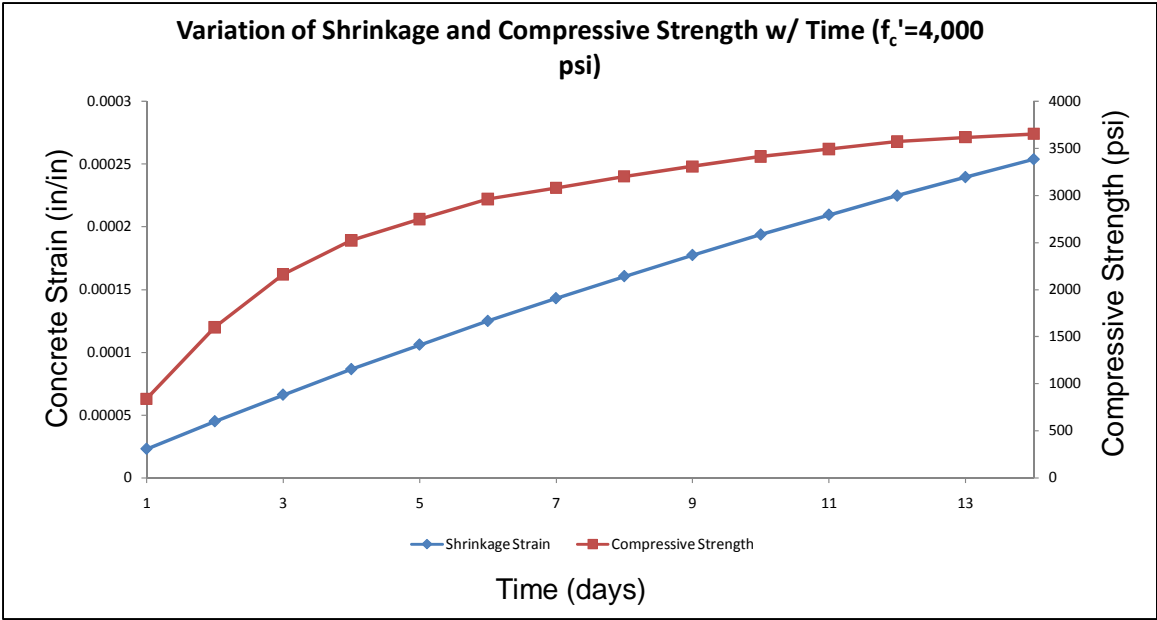
Figure 5.15 Variation of Shrinkage Strain and Compressive Strength (Komp 2009).

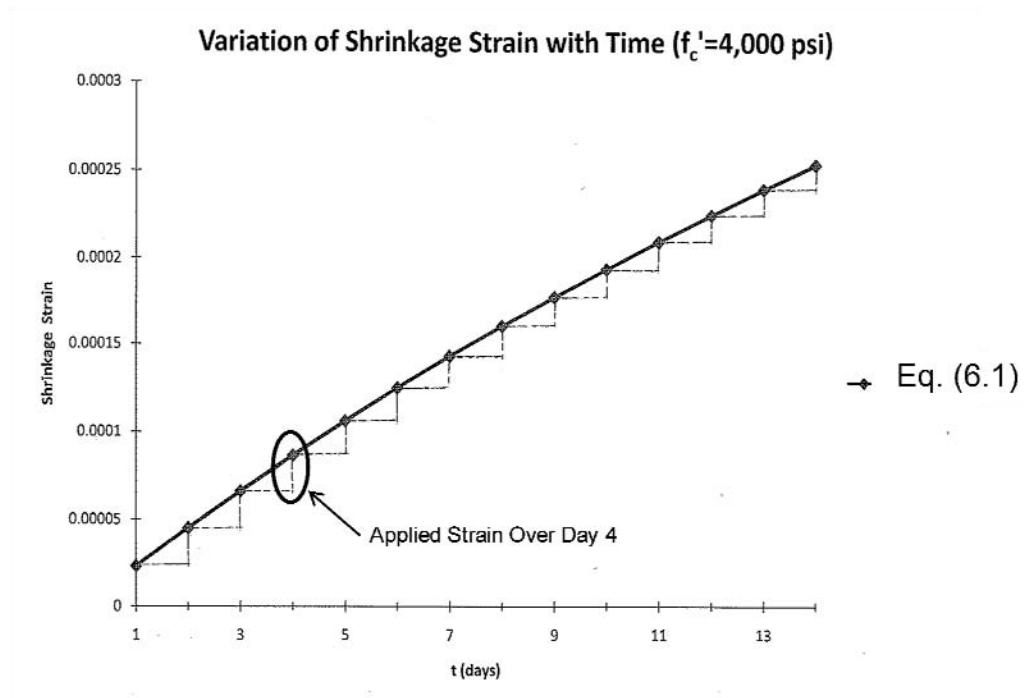
Figure 5.19 Step-Modeling Shrinkage Strain Variation with Time (Komp 2009).

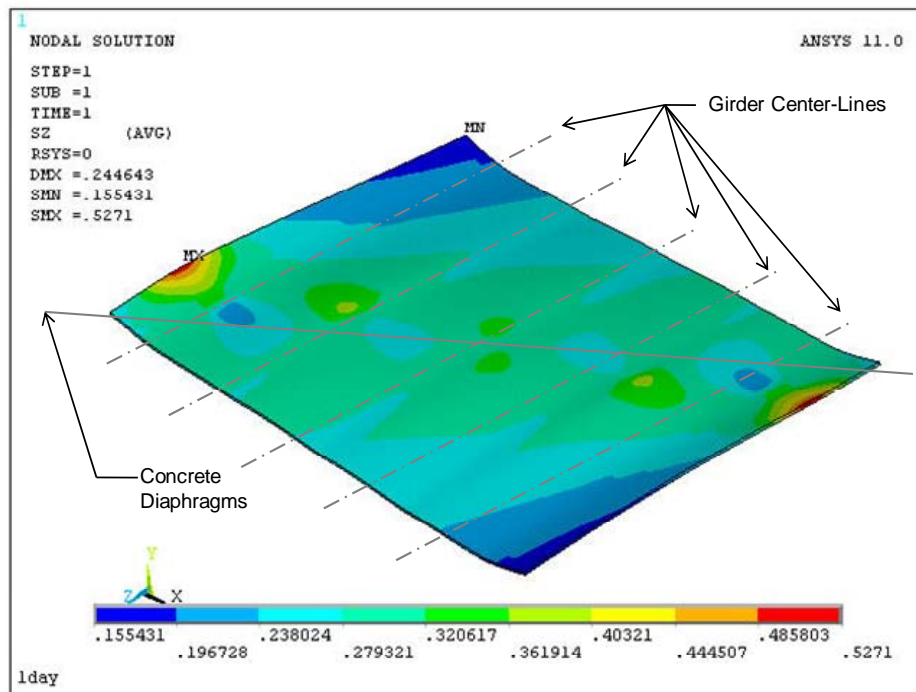
Figure 5.20 Longitudinal Stress Contour at Day 10 in Simulation (Komp 2009).

The finite element simulations conducted indicate that drying shrinkage appears to be capable of causing transverse (and possibly longitudinal) bridge deck cracking at very early stages in the life of the decks in the Waupun bridges. The simulations conducted indicate that cracking may occur as early as 4-8 days after bridge deck placement. An FE simulation of the tensile strains and stresses induced by HL-93 vehicle-type loading was conducted and it was found that tensile stresses induced by HL-93 vehicle loading were found to be on the order of 20% of the typical magnitudes assumed for the tensile strength of concrete material. When these are superimposed onto the states of stress likely present 10-days after casting the bridge deck, it is likely that the combined effects of vehicle-induced stresses and shrinkage-induced stresses will result in transverse cracking over the interior pier supports in the bridges in Waupun. The FE simulations conducted as part of this effort clearly support idea that there should be no difference between and IBRC bridge and its counterpart with regard to behavior leading to cracking since shrinkage-induced straining and traffic loading are the likely reasons for the transverse cracking. Furthermore, the deck connection detail at the central diaphragms (over the interior piers) in the FRP-SIP formwork bridge at Waupun is expected to neither improve nor detract from the behavior with regard to cracking.

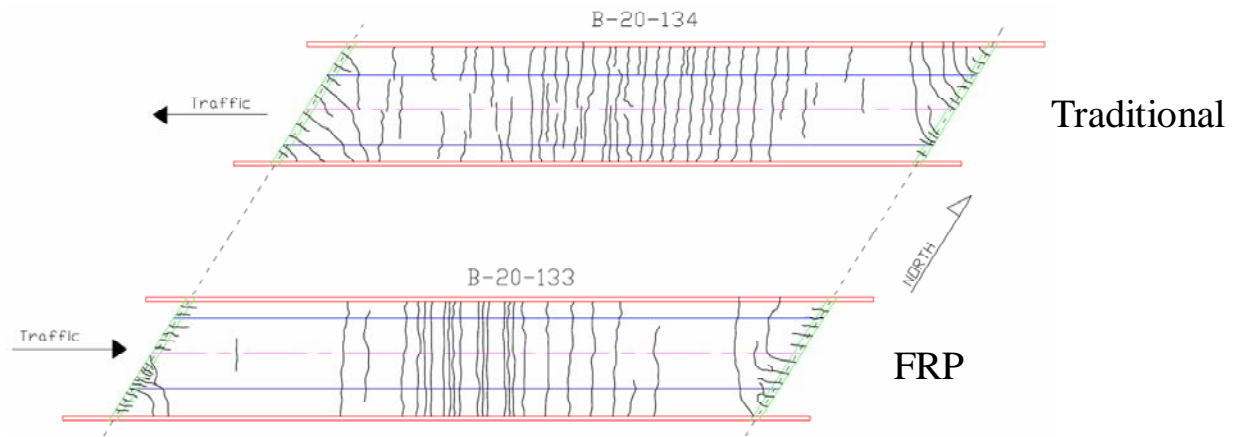
Figure 5.21 Waupun Bridge Crack Mapping (Martin 2006).

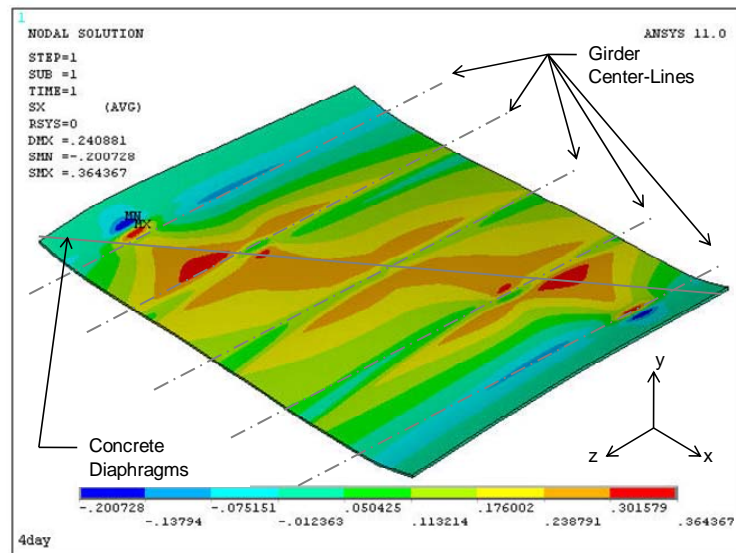
Figure 5.22 Transverse Stress Contour at Day 10 in Simulation (Komp 2009).
